Manhole Inspection Summary

Manhole # S29CC2008MH

Insp Date: **12/7/06 12:15 PM**

Location Address: **3 TAMWORTH RD**

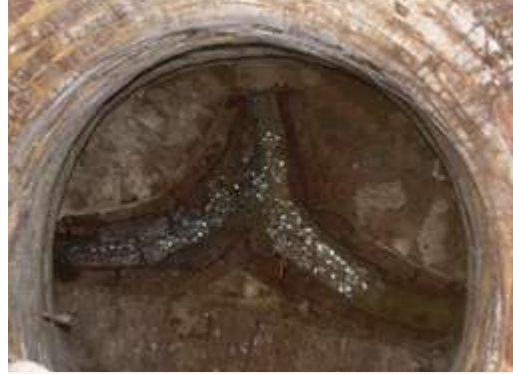
Top View

Evidence of surcharge - Bench debris.

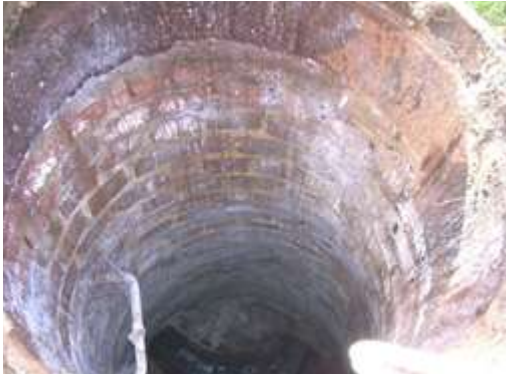
Defect

Frame leaks. Adjustment and Barrel infiltration - other side.

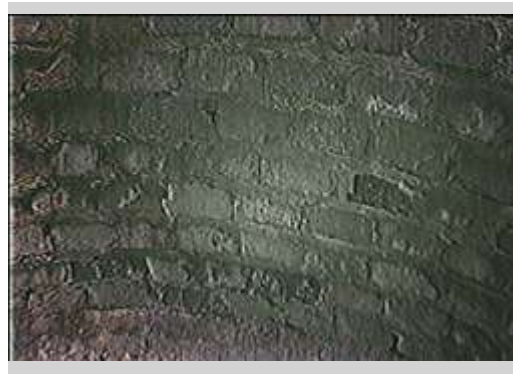
Defect

Condition: ☐ Sound ☐ Cracked ☐ Root Intrusion ☐ Loose Brick ☒ **Deteriorated**

Infiltration: ☐ None ☐ Joint ☐ Cracks ☒ **Mortar** ☐ Roots ☒ **Wall**

Barrel deterioration and infiltration.

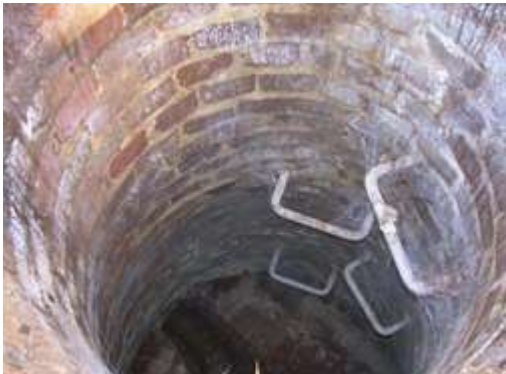
Defect

☒ **Leaks**

Infiltration: ☐ None ☒ **Joint** ☐ Cracks ☐ Mortar ☐ Roots ☒ **Wall**

Frame leaks. Adjustment and Barrel infiltration.

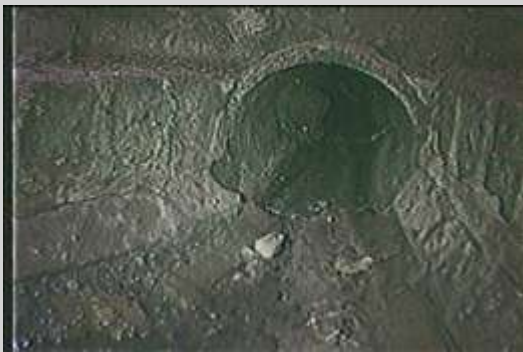
8 in. Circular Gravity Sewer Pipe Out @ 12 O'Clock

Infiltration: **Evidence** Pipe Seal Cond: **Cracked**

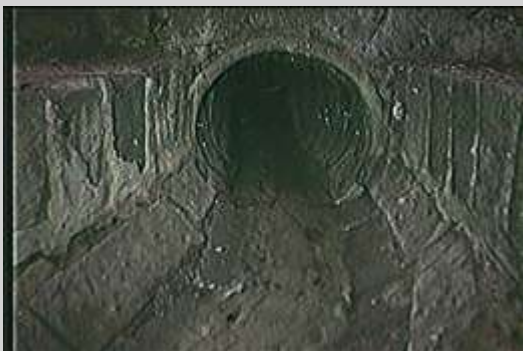
8 in. Circular Gravity Sewer Pipe In @ 3 O'Clock

Channel deterioration.

Infiltration: **Evidence** Pipe Seal Cond: **Cracked**
